USA-CERL TECHNICAL REPORT M-87/13, VOL. II
September 1987
Roofing Maintenance Management System

Membrane and Flashing Condition Indexes for Built-Up Roofs Volume II: Inspection and Distress Manual

by
Mohamed Y. Shahin
David M. Bailey
Donald E. Brotherson

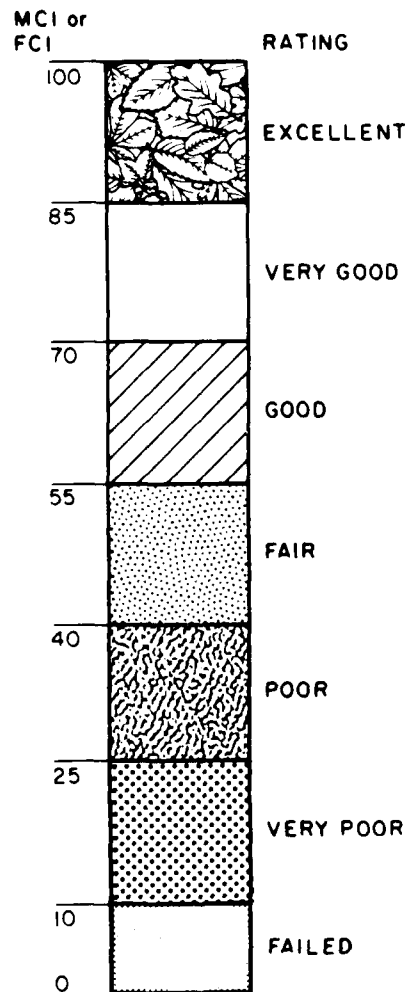
Figure 1. Membrane and Flashing Condition Indexes (MCI and FCI) and ratings.

The results of the roof inspection are to be used in conjunction with procedures in Chapter 2 to determine the MCI and FCI and their respective ratings (Figure 1). Deduct value curves are in Appendix A. A sample of the sheets to be used by the roof inspectors is provided in Appendix B.

5. Determine the condition ratings from Figure 1.

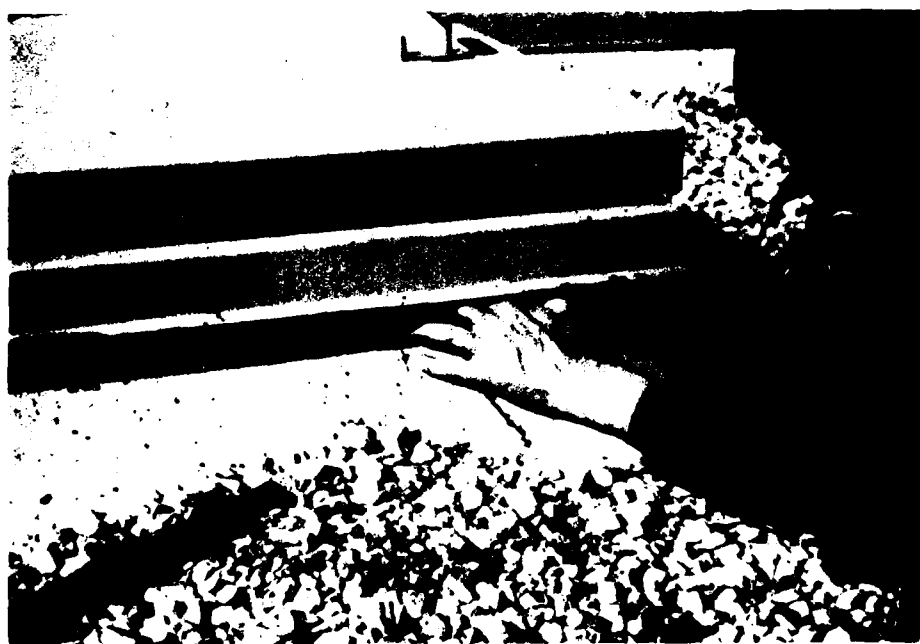
Figure 6. Check base flashing height by running fingers behind counterflashing.

Measure height of top termination of base flashing above the roof surface (Figure 5). To establish the height, run fingers up behind the counterflashing. If the base flashing height cannot be determined, assume it is adequate (Figure 6).

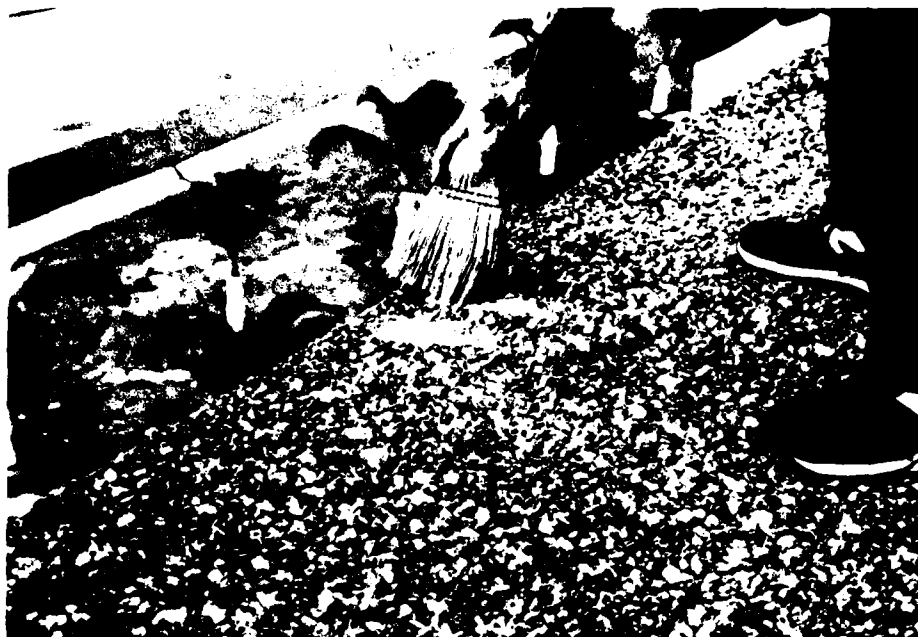
Figure 7. Sweep gravel back from embedded edge metal to expose joints.

Determine the total number of joints by dividing the total length of embedded edge metal flashing by the length of the edge metal sections (normally 10 ft). Inspect every fourth joint for splits in the stripping felts, removing any loose gravel or dirt from the joint using the small whisk broom and pointing trowel (Figure 7). Determine the number of inspected joints that are high severity (have splits in the stripping felts [Figure 8]) and multiply by 4 to get the total number of high severity joints (one joint equals 1 ft). All other joints are considered medium severity. Multiply the number of inspected joints not counted as high severity by 4 to obtain the total number of medium severity joints. Check that the embedded edge metal flashing is secure by attempting to lift the outside edge.

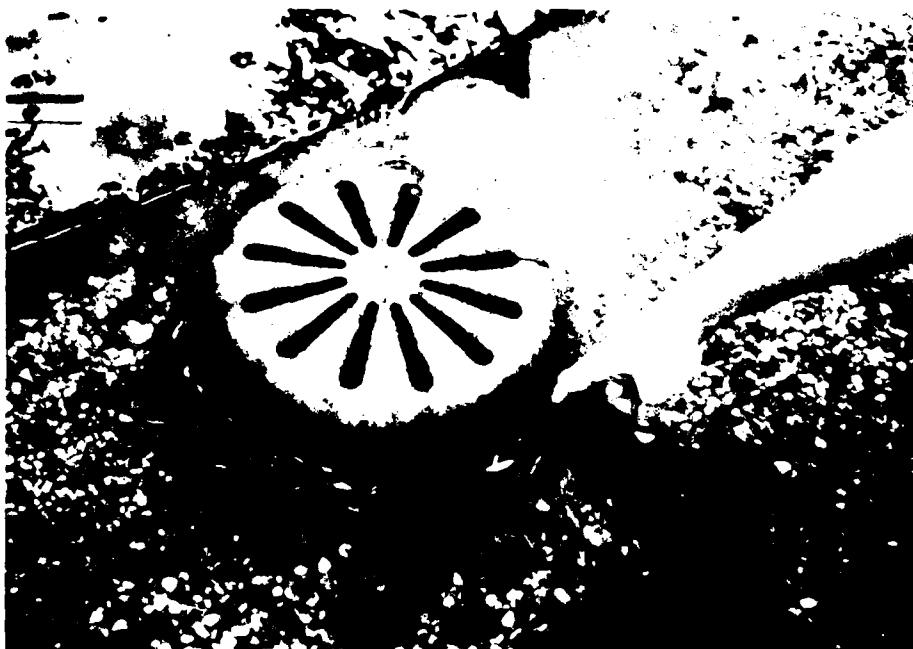
Figure 9. Roof drain clogged by debris.

Check all drains and scuppers and remove debris whenever possible (Figures 9 and 10). When inspecting drains, make sure the clamping ring is tight. Stripping felts around scuppers should be inspected for holes at corners.

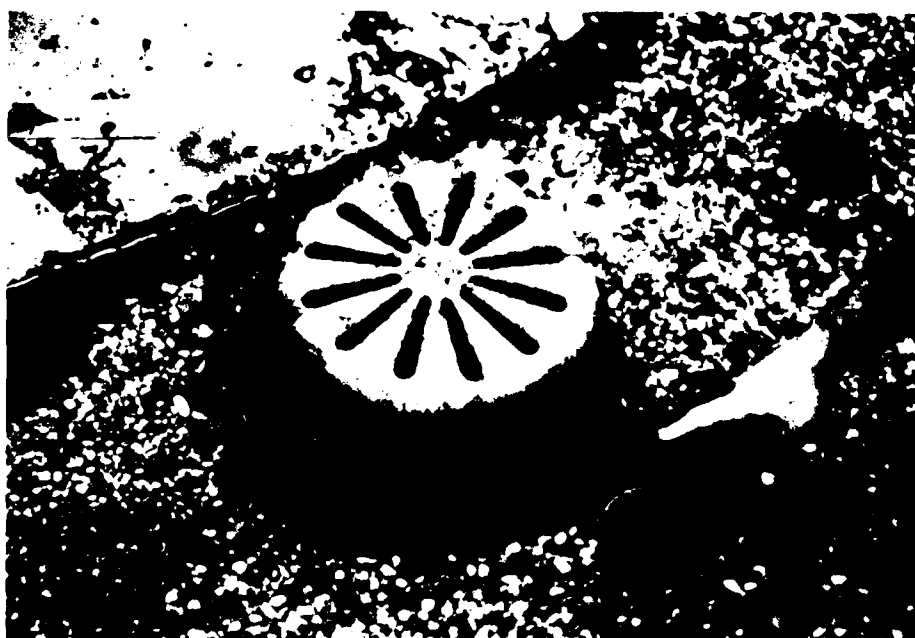
Figure 10. Removing debris frees the drain.

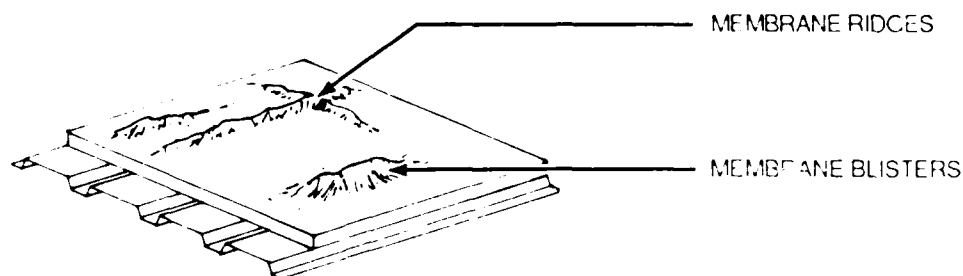
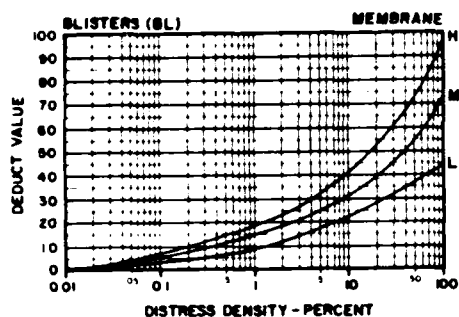
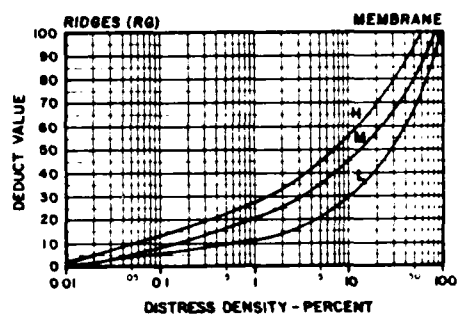
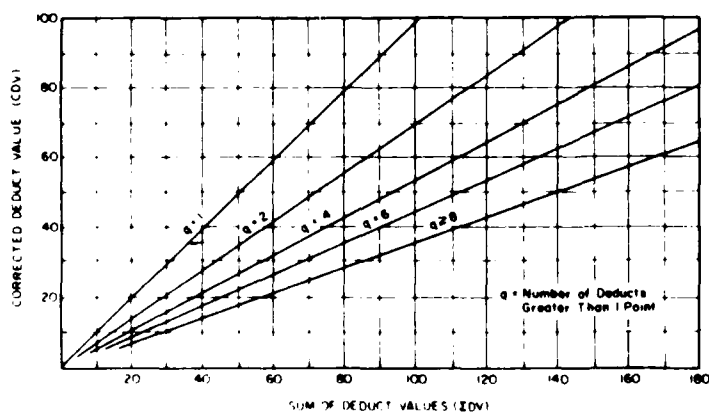
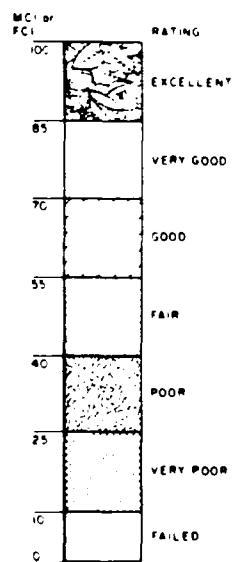
STEP 1 INSPECT ROOF DETERMINE DISTRESS TYPES AND SEVERITY LEVELS
DETERMINE QUANTITIES AND CALCULATE DENSITIES

STEP 2 DETERMINE DEDUCT VALUES.

STEP 5. DETERMINE MEMBRANE
CONDITION RATING.

STEP 3. COMPUTE CORRECTED DEDUCT VALUE.

STEP 4 COMPUTE MEMBRANE CONDITION INDEX (MCI) = 100 - CDV

Figure 13. Steps for determining roof membrane condition rating.

Once the condition survey is completed, determine the FCI and MCI for the roof section. Calculating the condition indexes is a simple procedure which involves five steps (Figure 13).

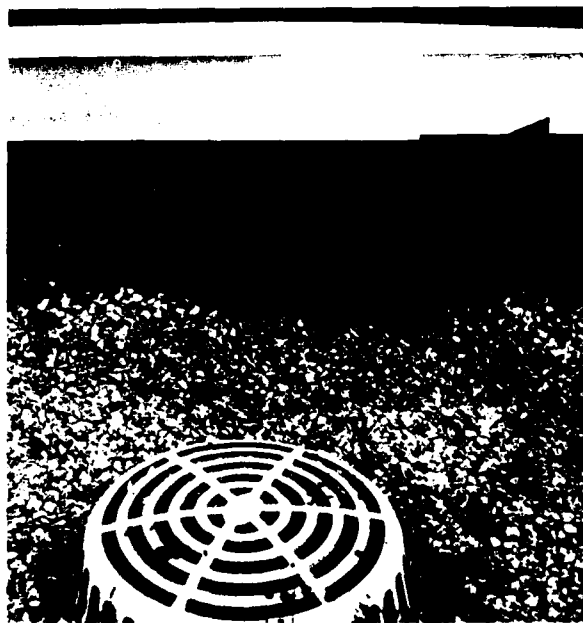
BF4 Base Flashing
 <Low Severity>
 Mineral surfacing is worn but
 surface is still intact

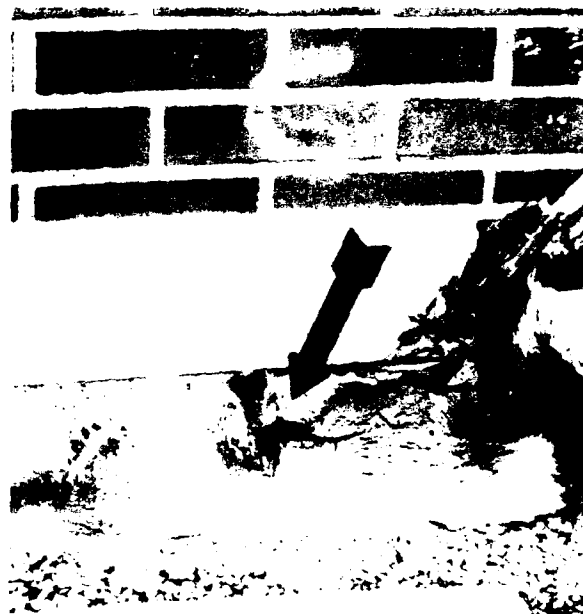
BF12 Base Flashing
<High Severity>
There is a hole through the
flashing material.

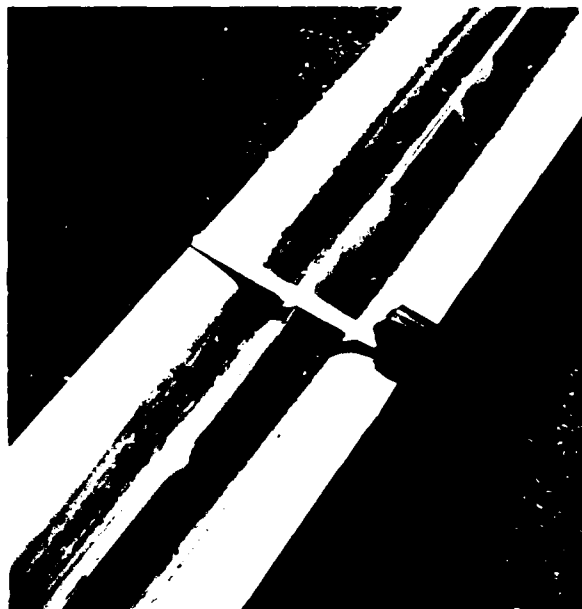
MC6 Metal Cap Flashing
 <Low Severity>
 Water can accumulate on top of
 the cap

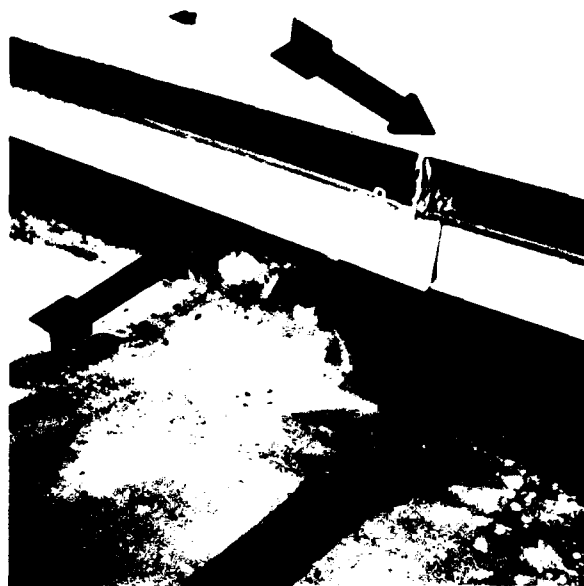
MC10 Metal Cap Flashing
 <Medium Severity>
 Joint in cap has failed; caulking has not corrected the problem.
 Also, Base Flashing has holes
 <High Severity>

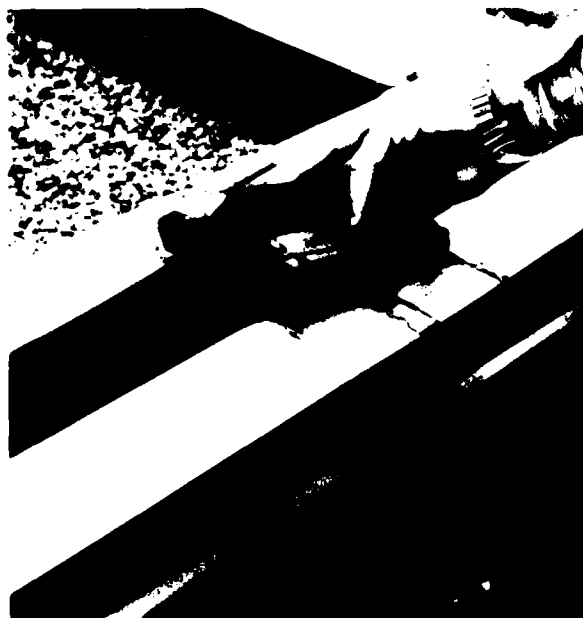
MC11 Metal Cap Flashing
 <Medium Severity>
 Neoprene cover at joint has failed

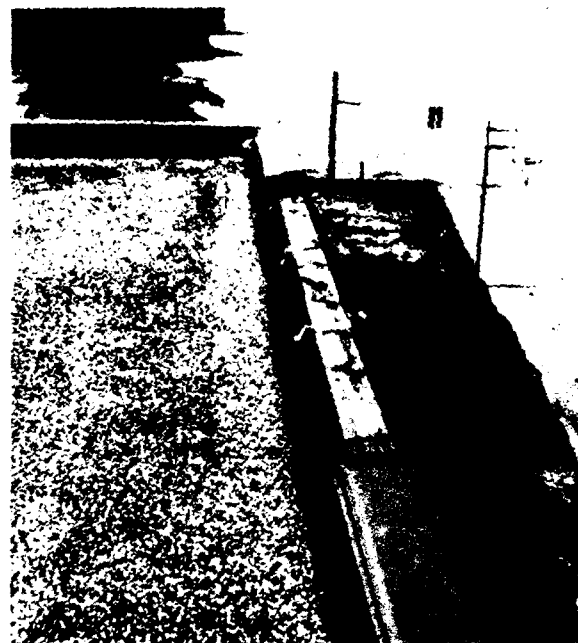
MC14 Metal Cap Flashing
 <High Severity>
 Joint covers are missing

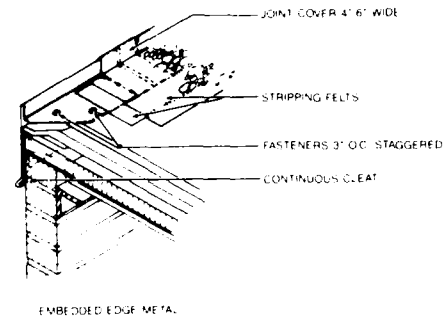
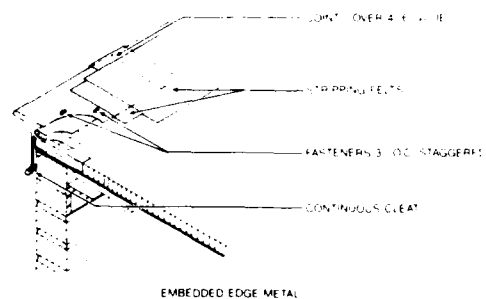
Embedded Edge Metal (EM)

Description: Formed strip of metal at the roof edge which continues down the vertical part of the wall to form a fascia or drip. This stripped-in flashing provides a finished termination for the roofing membrane. A formed vertical projection (gravel stop) may be incorporated to prevent loose aggregate from rolling or washing off the roof. Exterior and interior gutters, which are embedded into the membrane, are considered as embedded edge metal. (An interior gutter is a built-in trough of metal or other material which collects water from the roof and carries it to a downspout.)

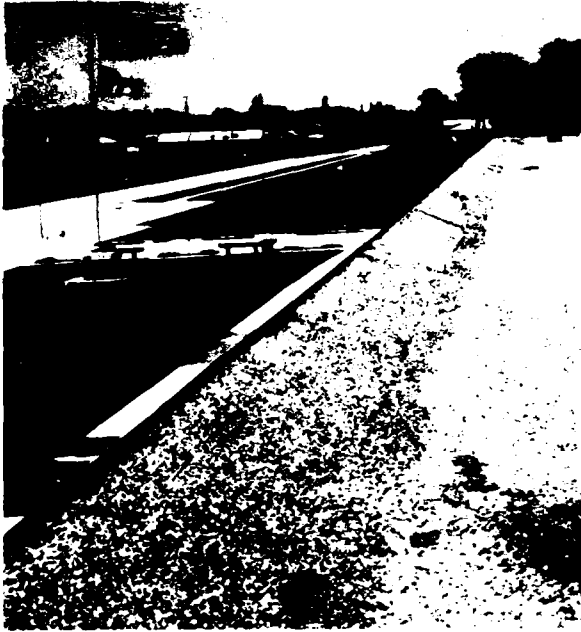
EM1 Embedded Edge Metal
 <Low Severity>
 Tapered edge metal is raised but
 strip-in still presents a potential
 hazard

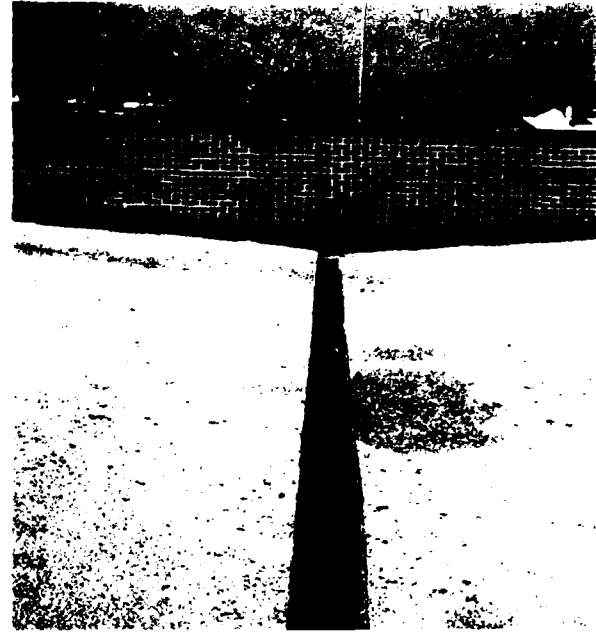
EM2 Embedded Edge Metal
 <Medium Severity>
 There are interior gutters

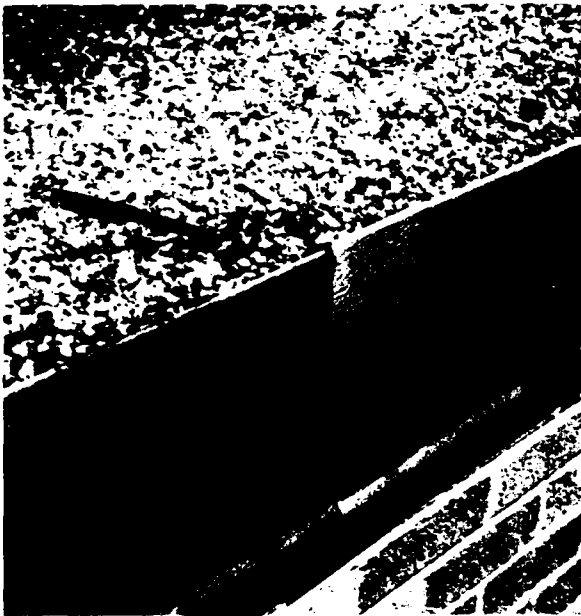
EM3 Embedded Edge Metal
 <High Severity>
 The stripping shows the beginning of
 a tear or break

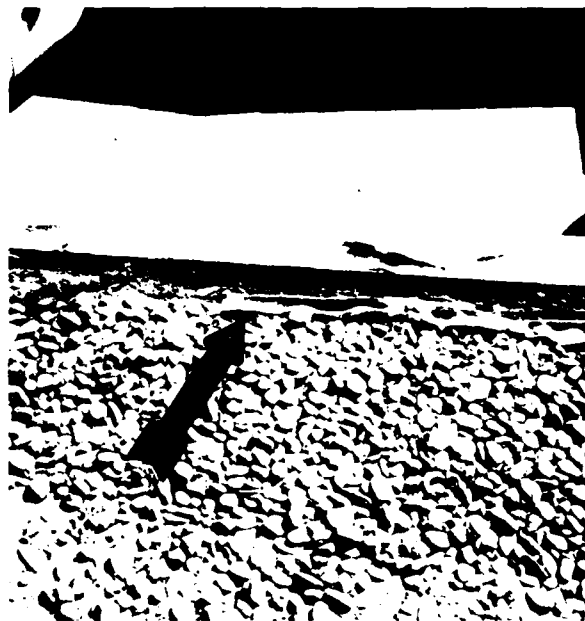
EM11 Embedded Edge Metal
 <High Severity>
 The stripping is torn

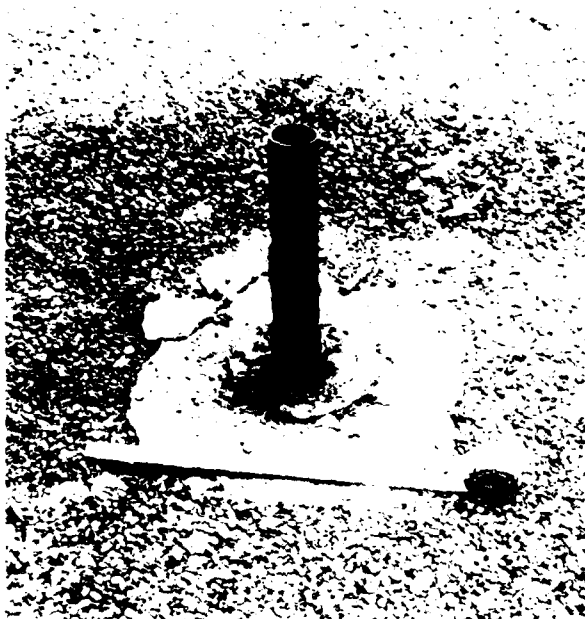
FP13 Flashed Penetration
 <High Severity>
 Unflashed pipe penetration sealed
 with roofing cement

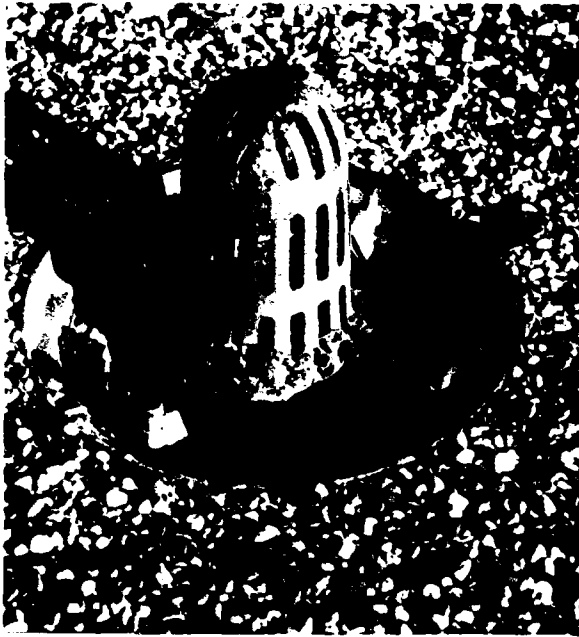
DR1 Drains and Scuppers
 <Low Severity>
 Bituminous material has flowed into
 the drain

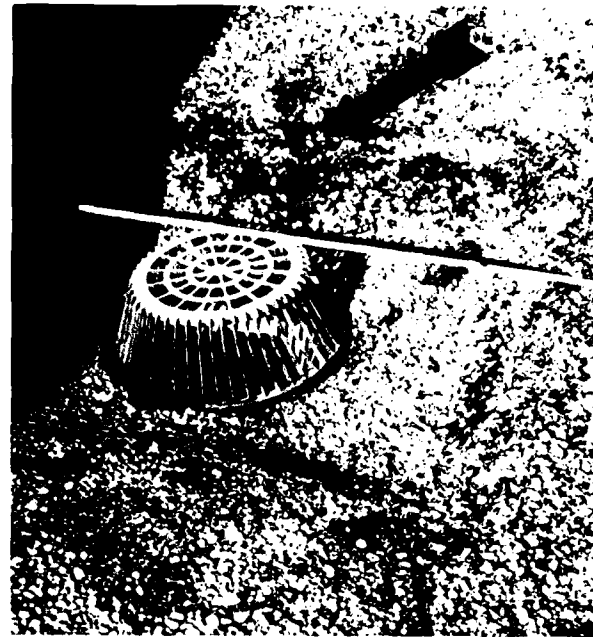
DR2 Drains and Scuppers
 <Medium Severity>
 The felts around the drain are
 exposed

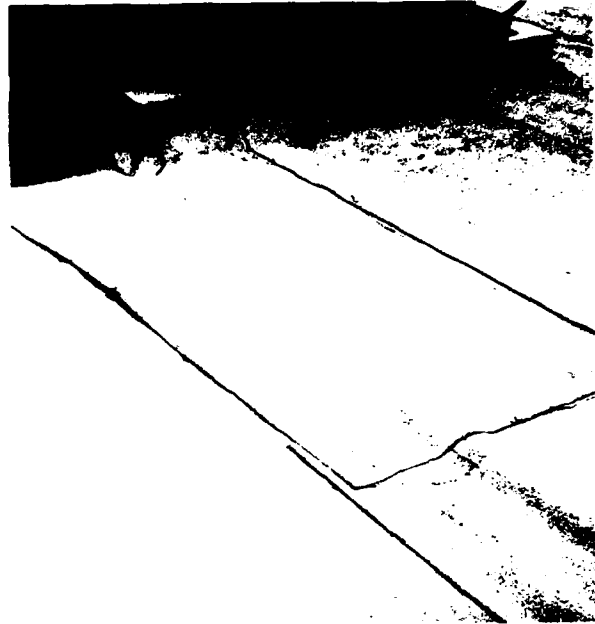
BL6 Blisters
<Low Severity>
Blisters in cap sheet

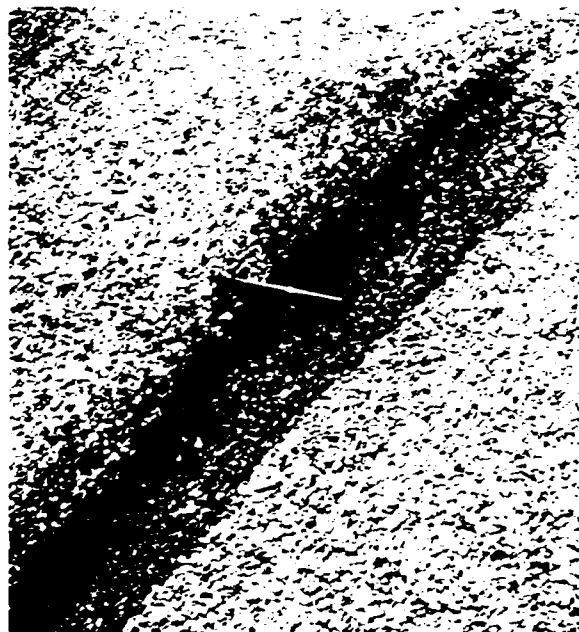
RG6 Ridges
 <High Severity>
 Felts are distorted; felt lap is
 opening up; first felt shows
 deterioration

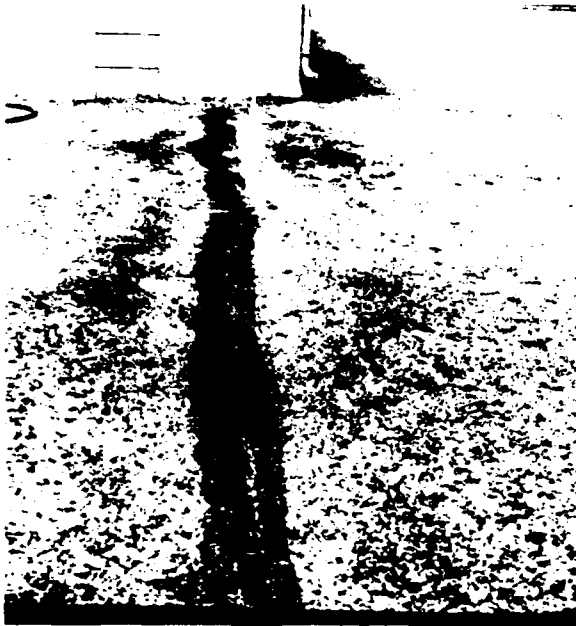
SP1 Splits
 <High Severity>
 Long split over structural member;
 yellow markings indicate water
 penetration determined by infrared
 (IR) scanning

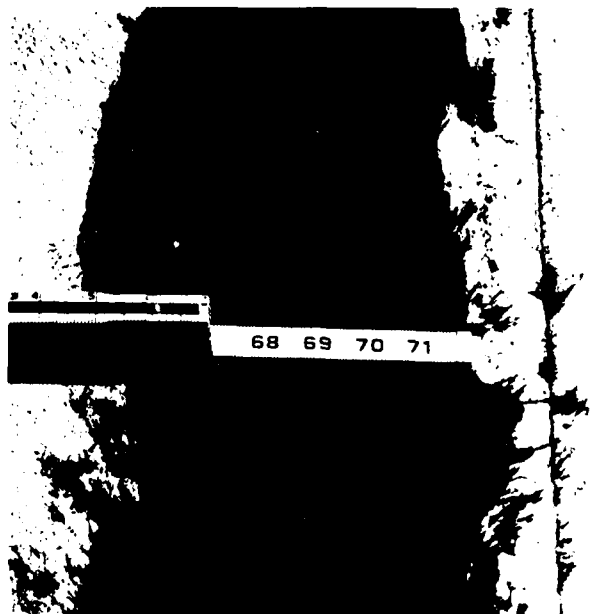
SP4 Splits
 <High Severity>
 Split in mineral cap sheet

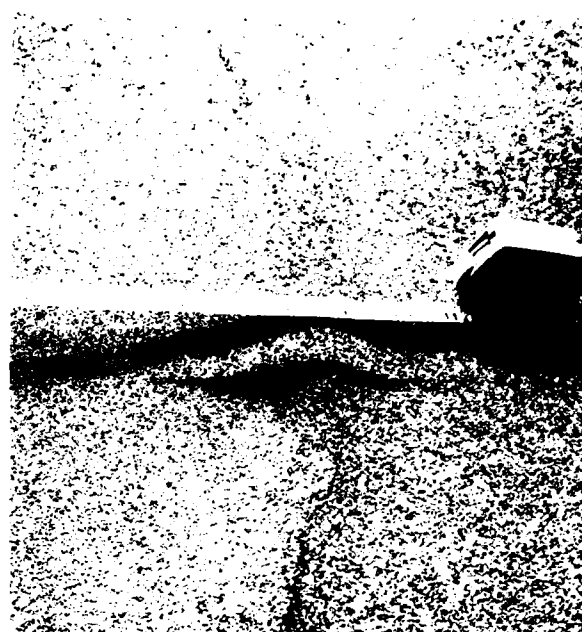
SR2 Surface Deterioration
 <Low Severity>
 There are open edge laps or
 fishmouths

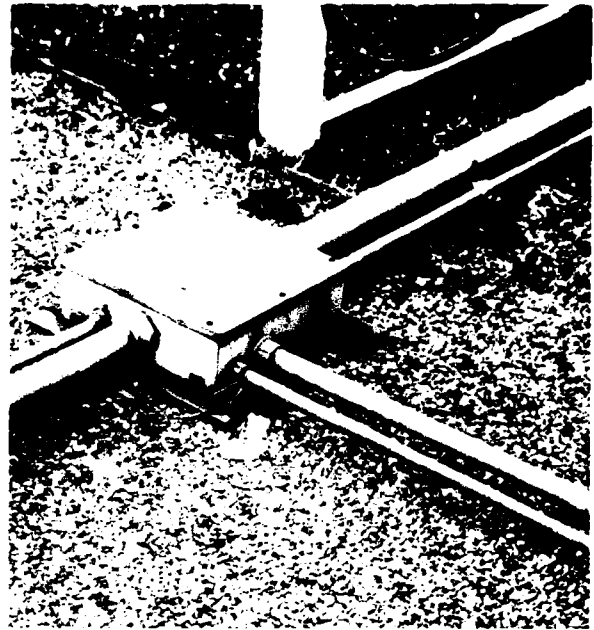
EQ2 Improper Equipment Supports
 <Low Severity>
 Conduit supported by wood blocks

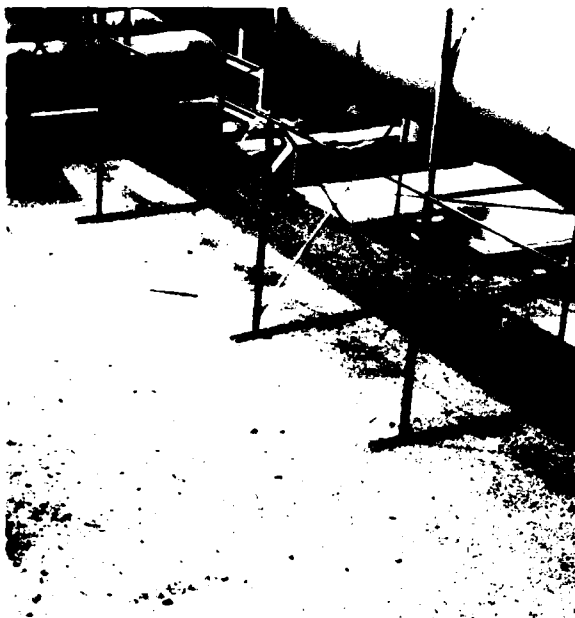
EQ3 Improper Equipment Supports
 <Low Severity>
 Ductwork supported on steel channels
 which rest on the membrane, unflashed

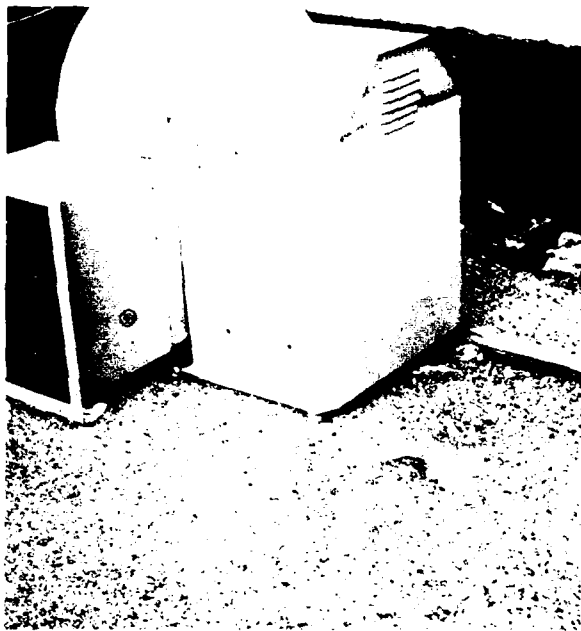
EQ5 Improper Equipment Supports
 <Medium Severity>
 Air handling equipment installed
 directly on the roof surface

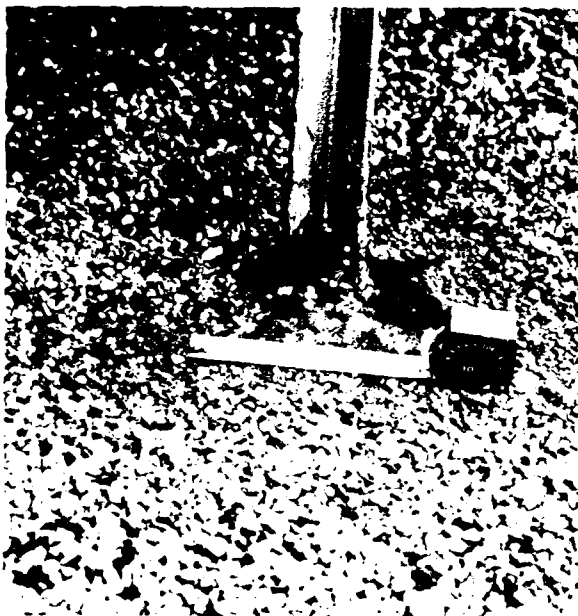
EQ7 Improper Equipment Supports
 <High Severity>
 Angle leg set on roof without
 flashing

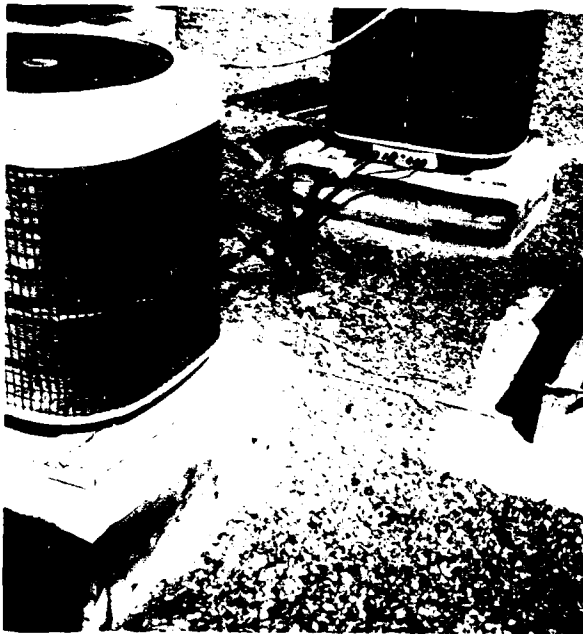
EQ9 Improper Equipment Supports
 <High Severity>
 Improper A/C support and pipe
 penetration

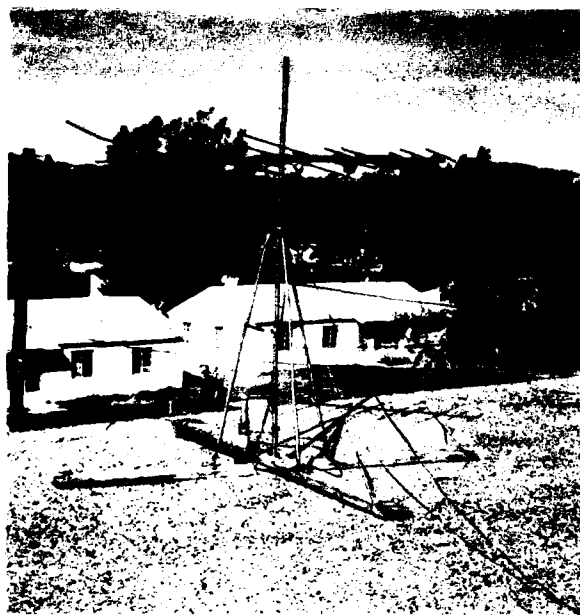
EQ11 Improper Equipment Supports
 <High Severity>
 Antenna base is nailed to roof

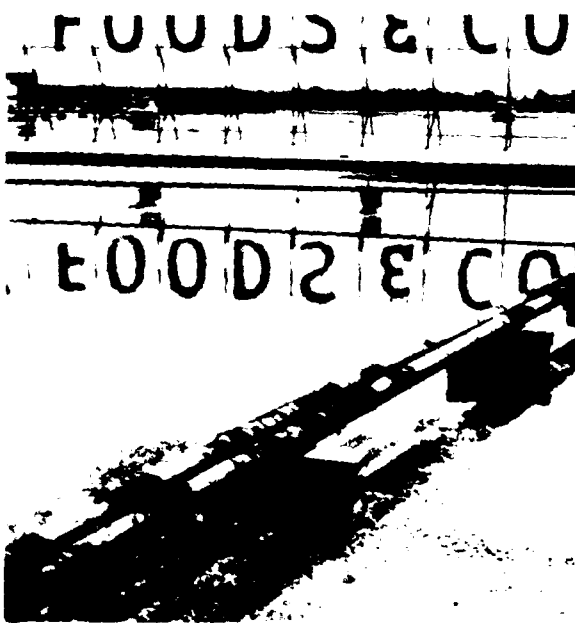
PD5 Ponding
<Low Severity>
Ponding on roof

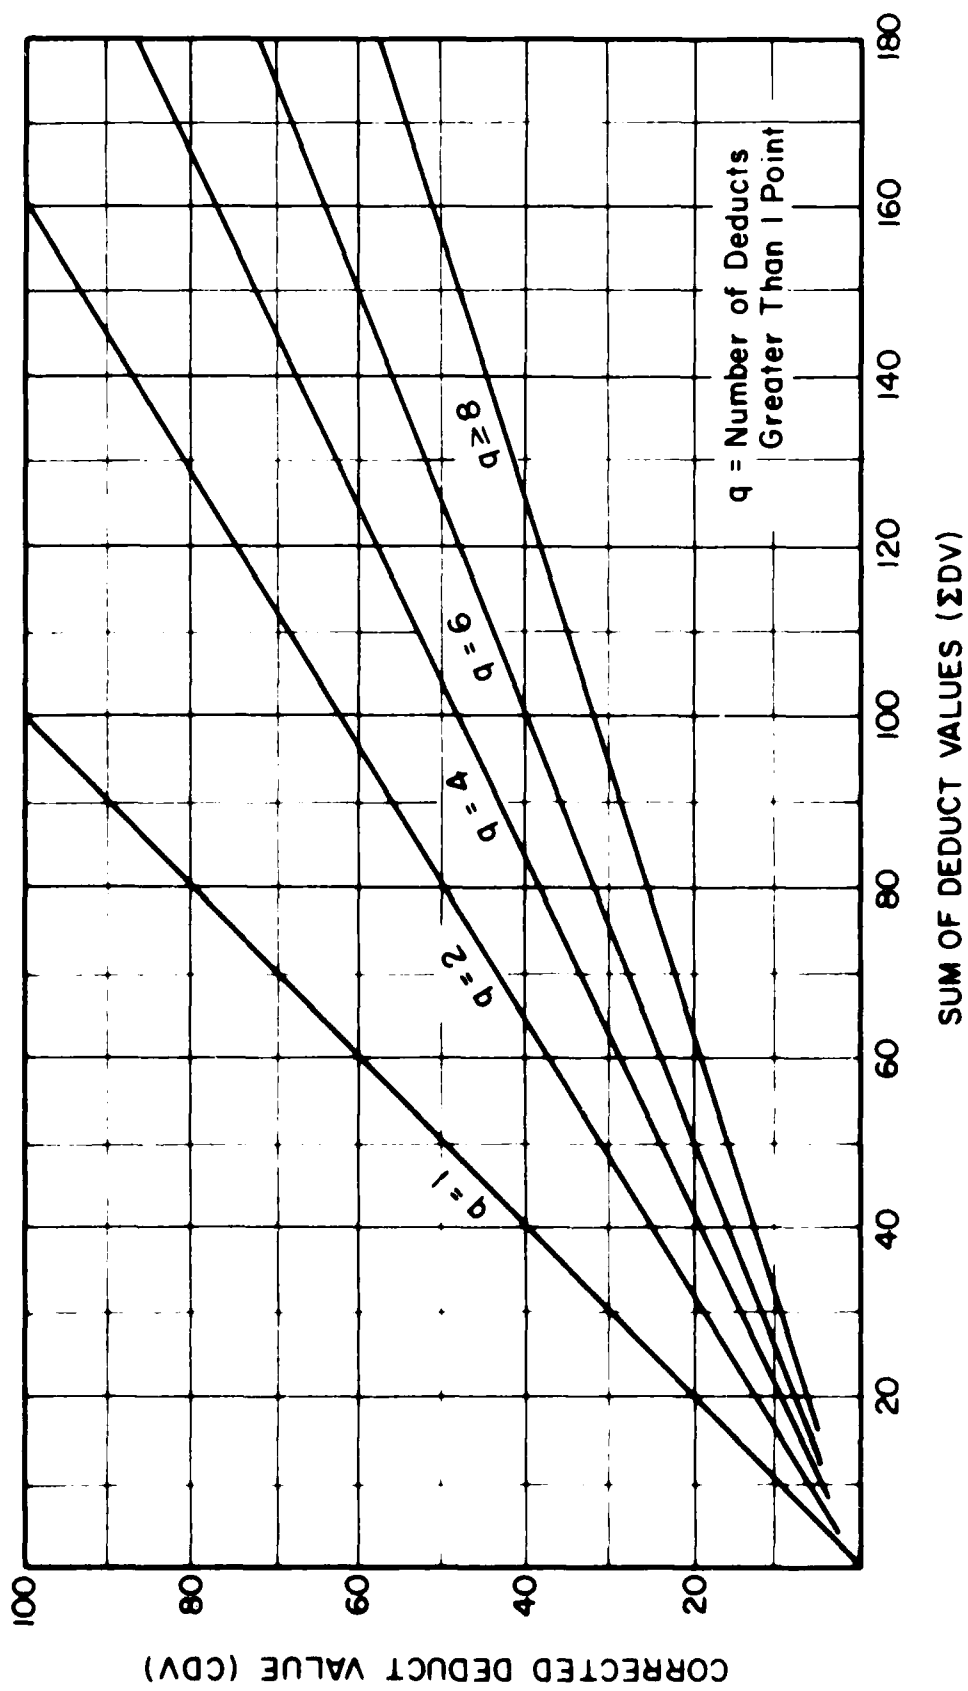
Corrected deduct values for flashing.

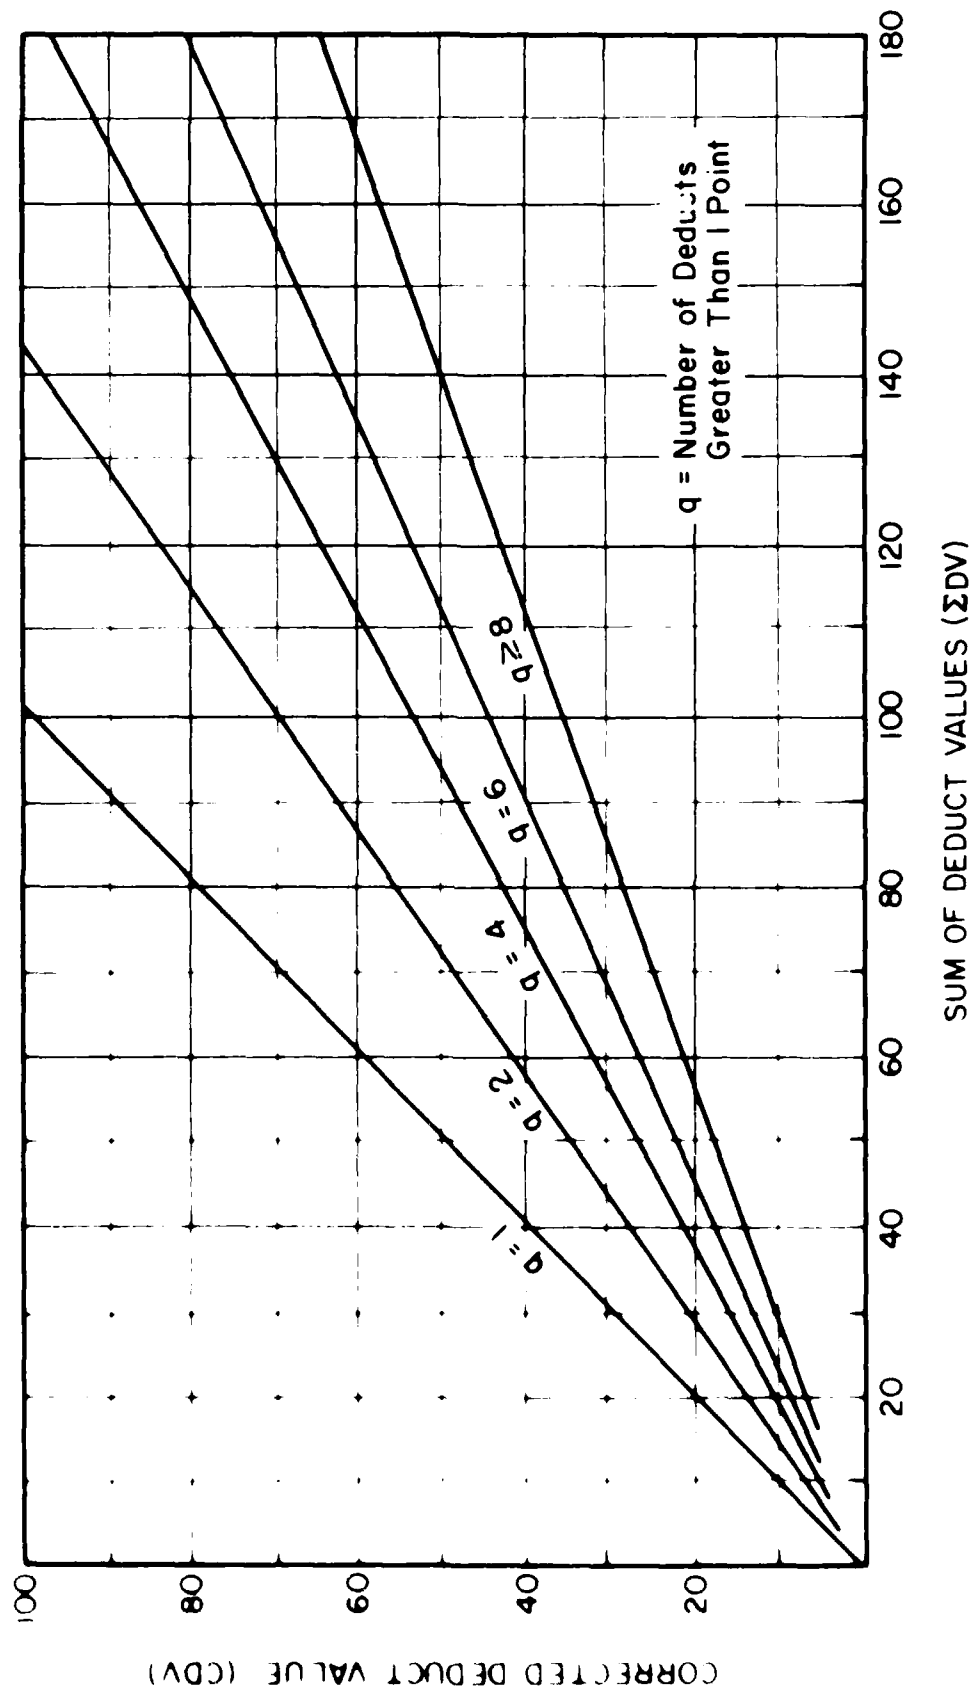
Corrected deduct values for membrane.
